Inspection Report

PROPERTY INSPECTION REPORT

Concerning: Sample report, , _____
(Address or Other Identification of Inspected Property)

By: Richard Chandler # 6803 6803 / Insight Property Inspections 2/20/2014
(Name and License Number of Inspector) (Date)

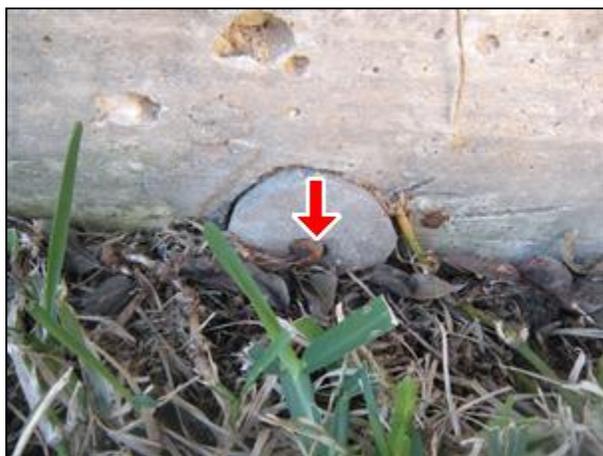
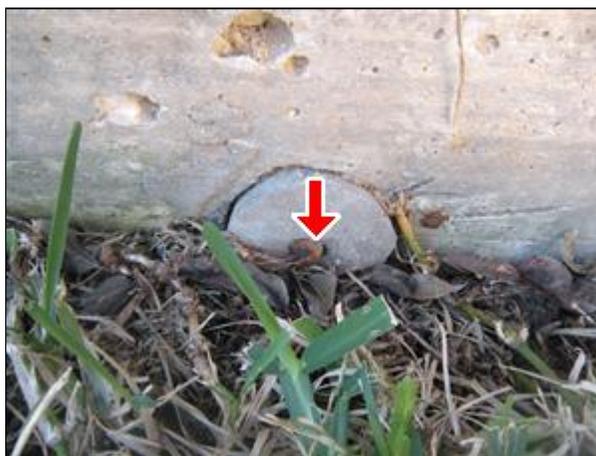
- 🏠 (2) Post tension cable ends are exposed and need to be properly sealed along the rear of the house. Post tension cables should be cut flush with the foundation edge and sealed against moisture intrusion. Moisture may enter the stranded cable and wick its way further down the cable inside the sheath that surrounds it. When this happens the cable can rust and will eventually fail.

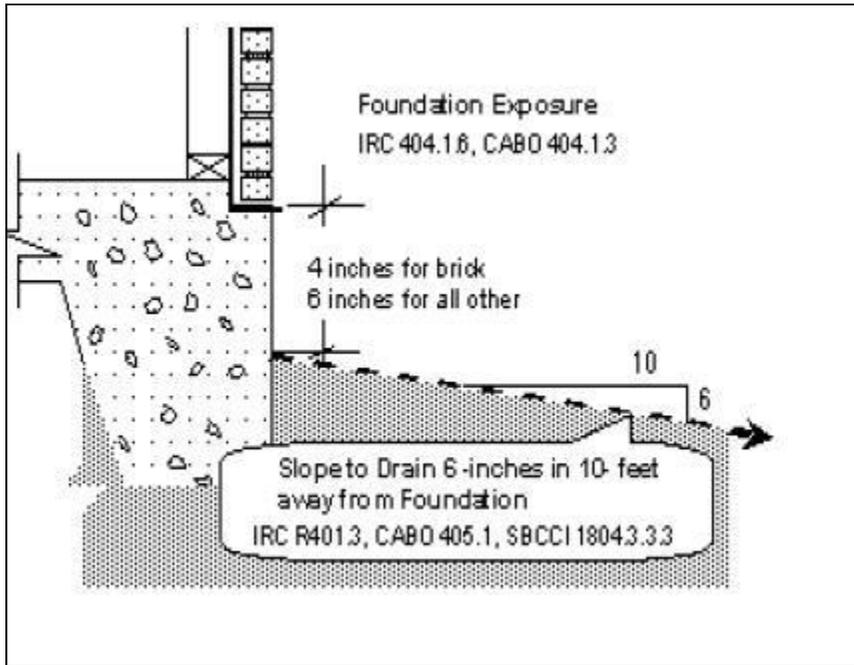
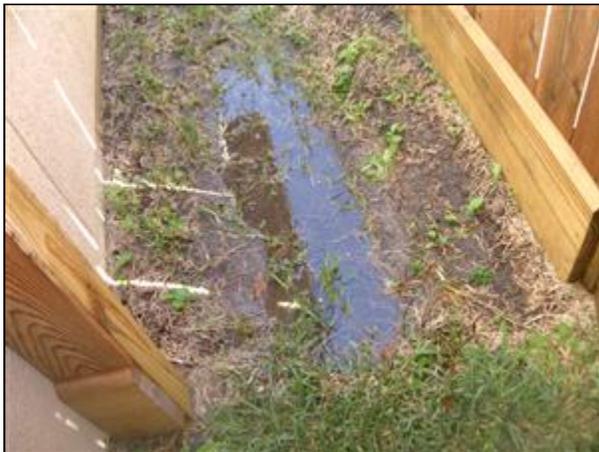
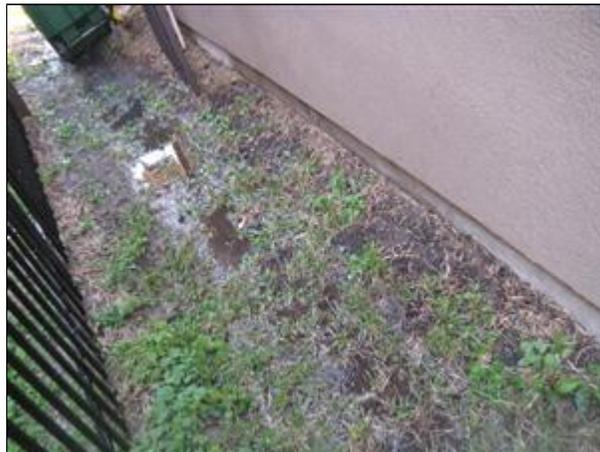
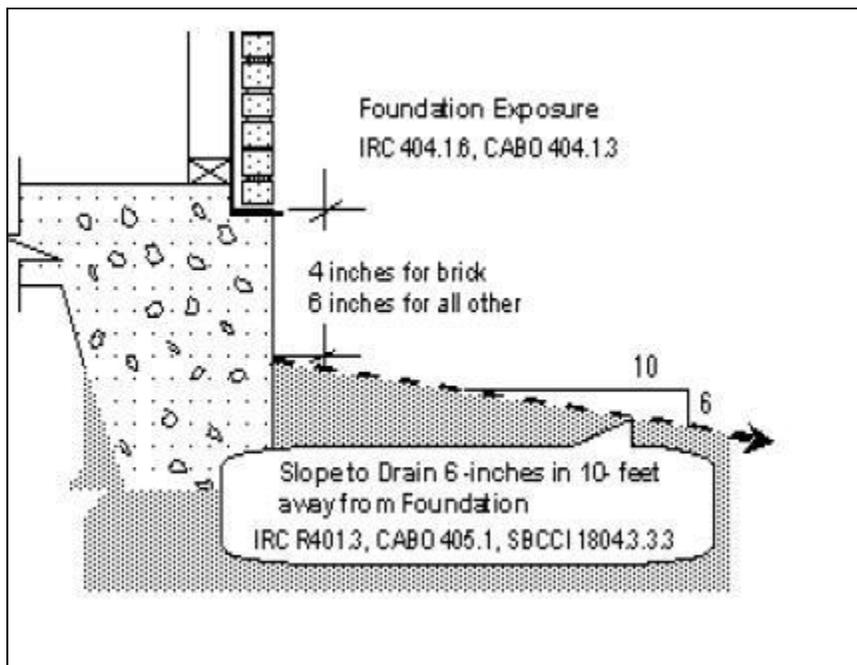
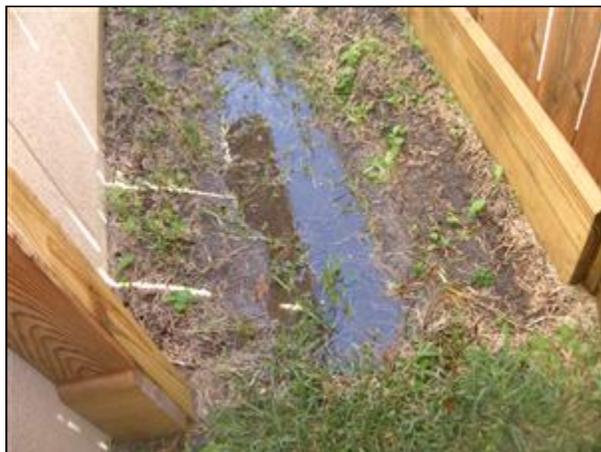
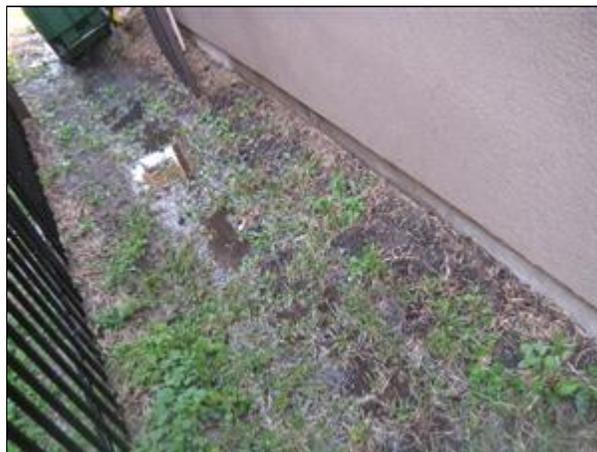
- 🏠 Drainage patterns, at the right of the house, do not appear to properly direct water away from foundation to aid in controlling runoff water and could cause differential movement of the foundation or water penetration during heavy rains. Proper slope away from the foundation is 6 inches in 10 feet. These areas should be regraded to slope away from the foundation.

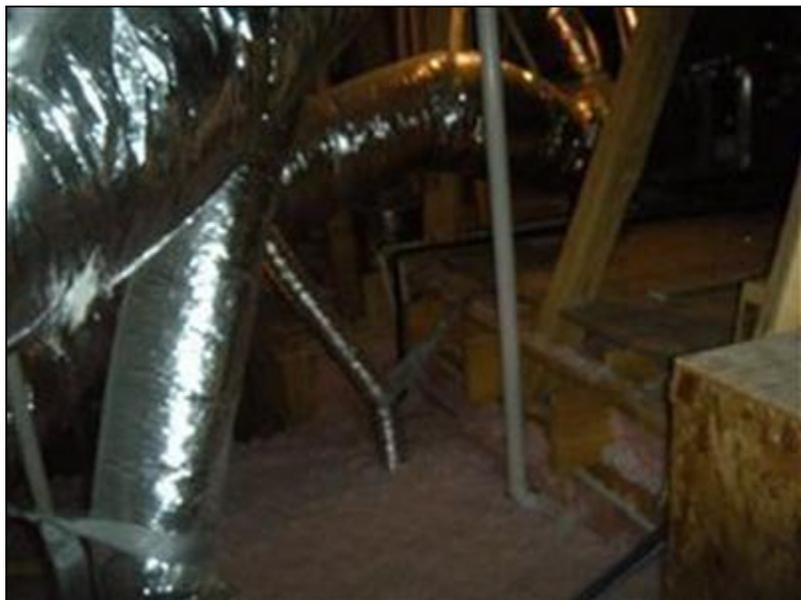
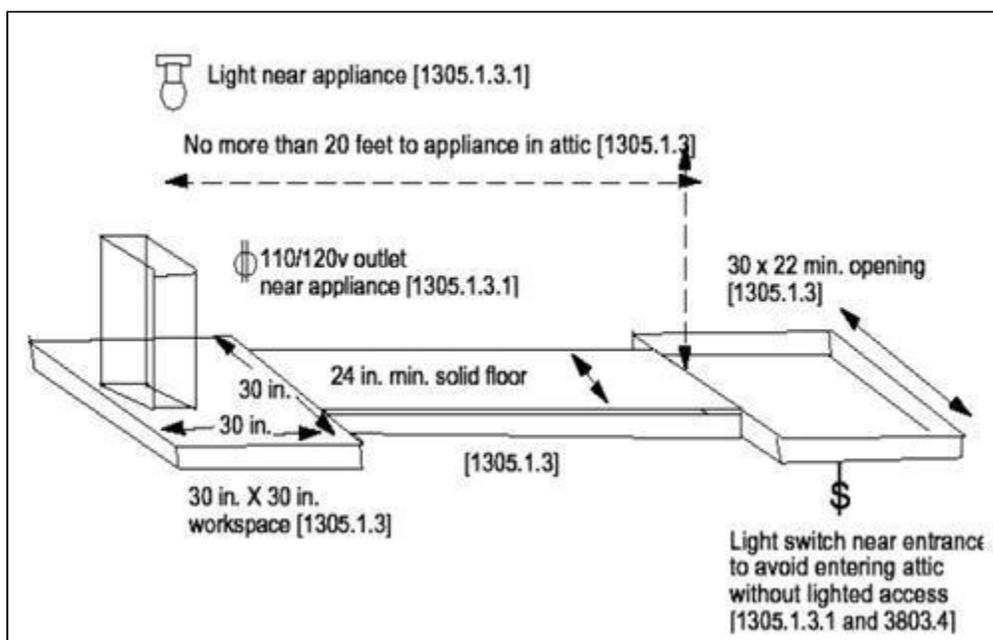
(1) Under current building standards, a continuous unobstructed attic service walkway as normal flooring, minimum 24" wide, leading to the HVAC units and other equipment from the folding stair opening, shall be installed. This is a recognized safety (trip) hazard and the gas line and water pipes are not protected from damage and is in need of repair

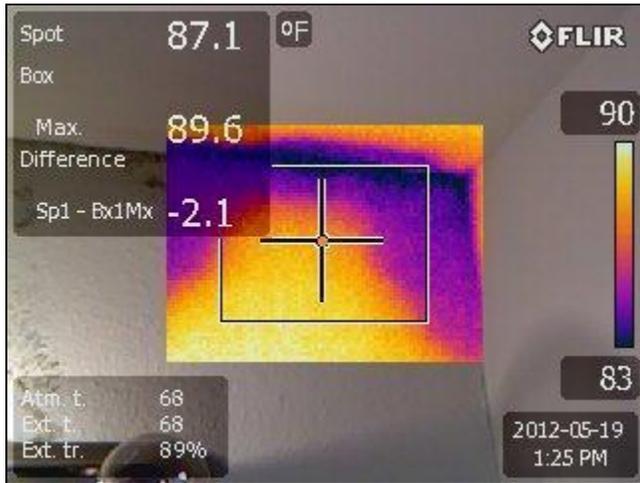
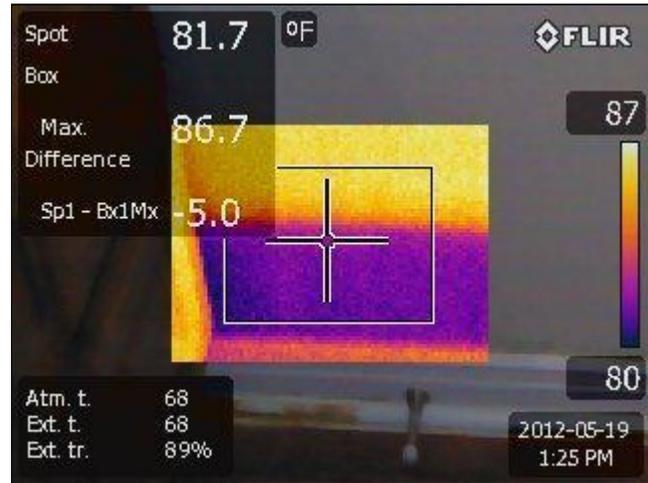
- 🏠 (1) Moisture was observed at the walls and ceiling in the hall bathroom, above the sink and near the cabinet. A qualified contractor should inspect and repair as needed. Signs of fungi growth are present on the walls . We did not inspect, test or determine if this growth is or is not a health hazard. The underlying cause is moisture or dampness. I recommend you contact a mold inspector or expert for investigation or correction if needed.

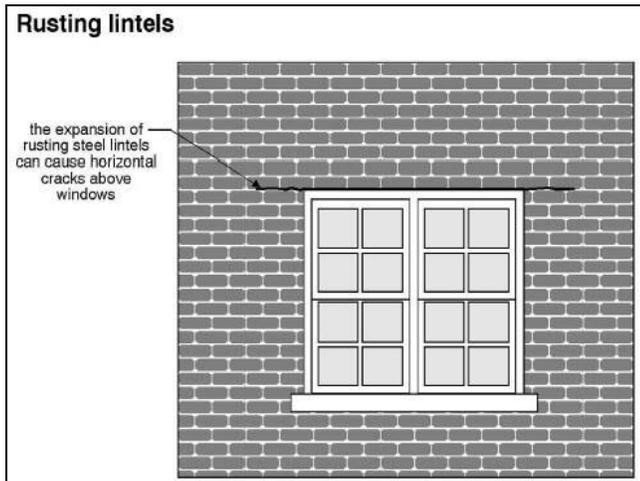
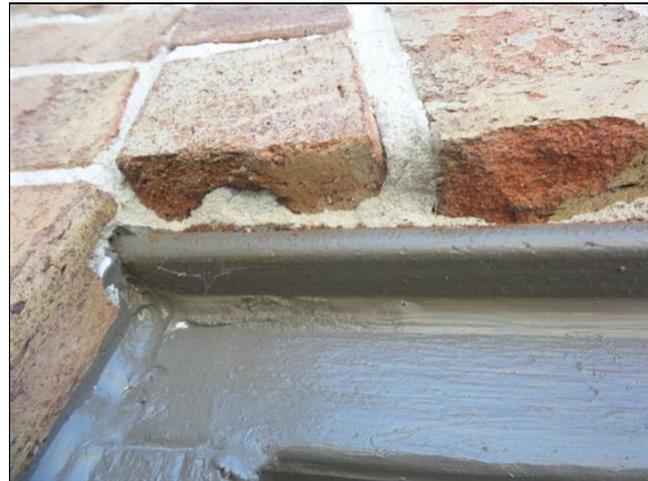
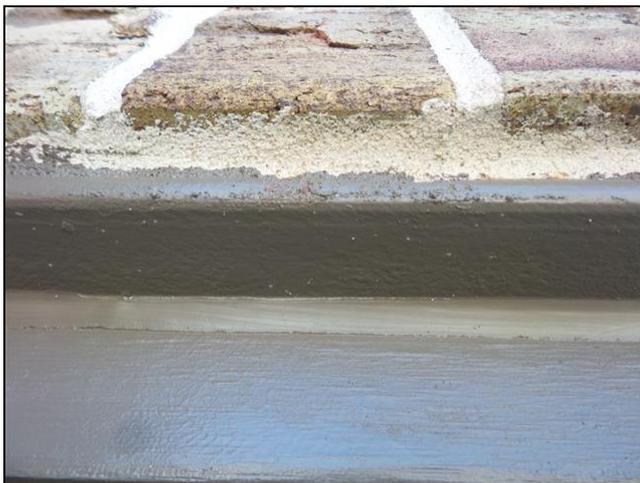
(2) Rusty steel lintels noted. Steel lintels, used above doors and window openings to support the brick on brick walls, should always be protected from the elements with a thorough coat of paint. Failure to maintain the lintels will allow them to rust and expand which will eventually crack the brick and mortar around the lintels. Removal of the existing rust, priming of the steel and painting is recommended.

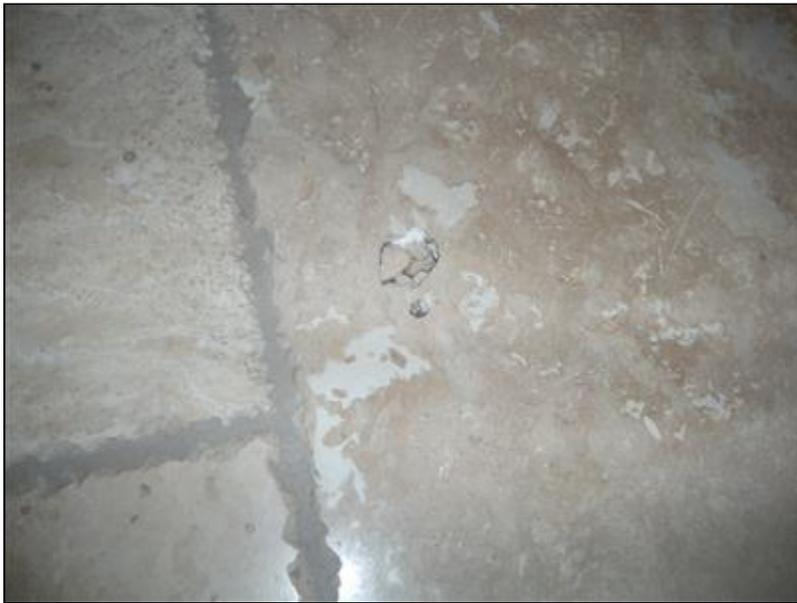
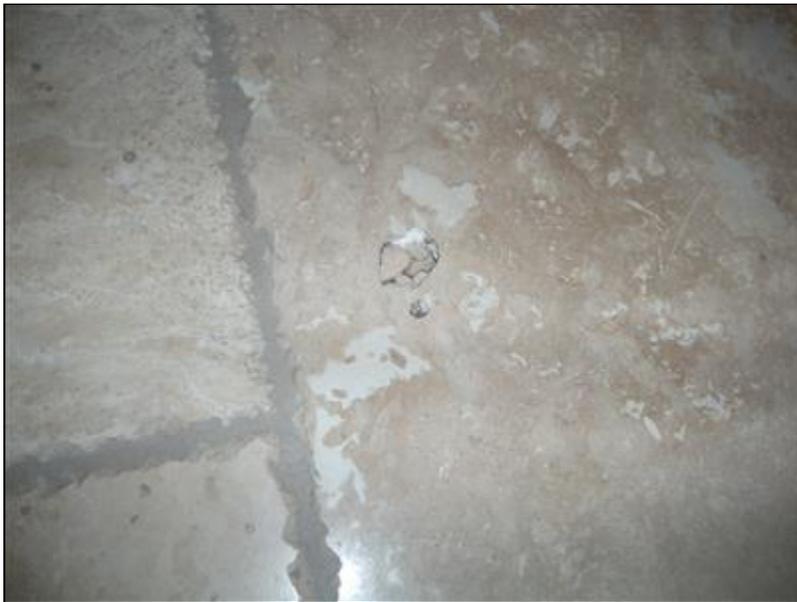
Damaged floor tiles were observed in several areas throughout the down stairs.

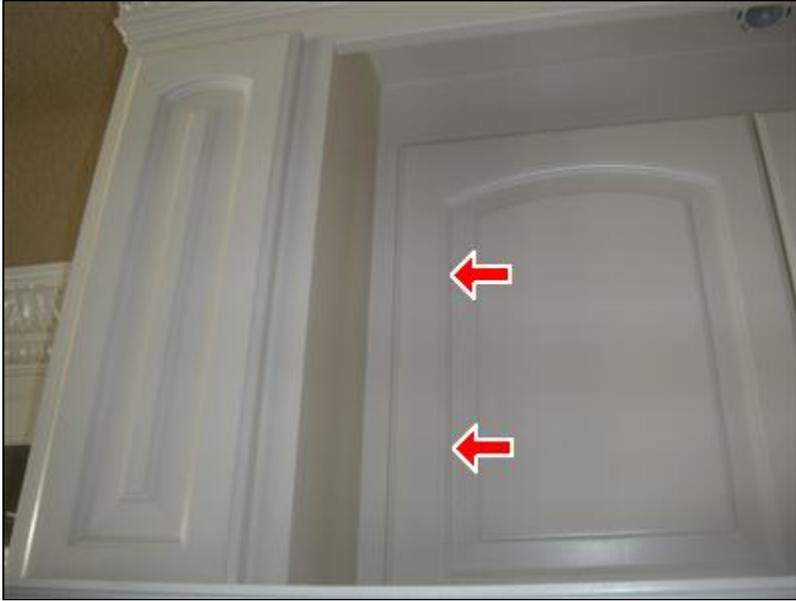
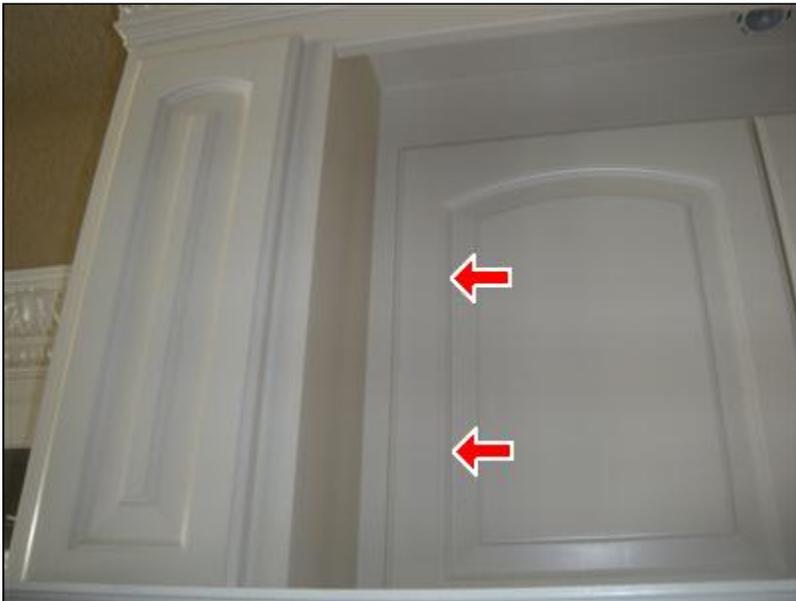
Cabinet door (s) is cracking in areas (above the cooktop). This is a cosmetic issue for your information. Recommend repair or replace as necessary.

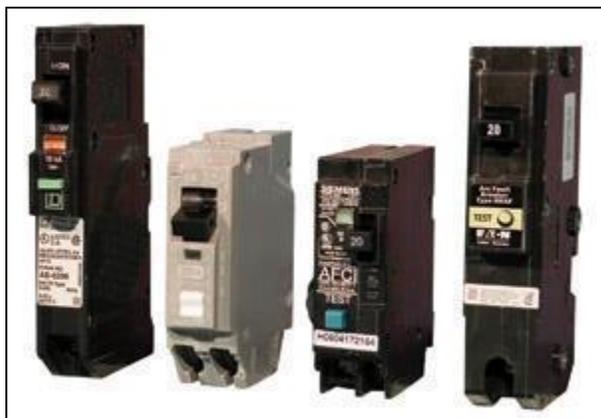
A. Item 1(Picture)

(2) AFCI devices were observed at breakers serving the bedrooms, however, no AFCI protection was observed at common area breakers. AFCI (Arc Fault Circuit Interrupt) device protection, as required by current building standards, for all: family rooms, dining rooms, living rooms, parlors, libraries, dens, bedrooms, sunrooms, recreations rooms, closets, hallways, or similar rooms or areas. AFCI devices are intended to protect against fires caused by electrical arcing faults in the home's wiring. Arc faults are a common cause of residential electrical fires. Arc faults can be created by damaged, deteriorated, or worn electrical plugs, cords, and/or branch circuit. conductors. As of September 1, 2008, the State of Texas has adopted the 2005 NEC, which includes this requirement, as the "minimum standard" for all non-exempt electrical work. Homes built prior to 2002, generally were not required to have arc fault protection. However, the current TREC standard of practice requires inspectors to indicate that a hazardous or deficient condition exists if any home does not have this protection, regardless of date the home was constructed.

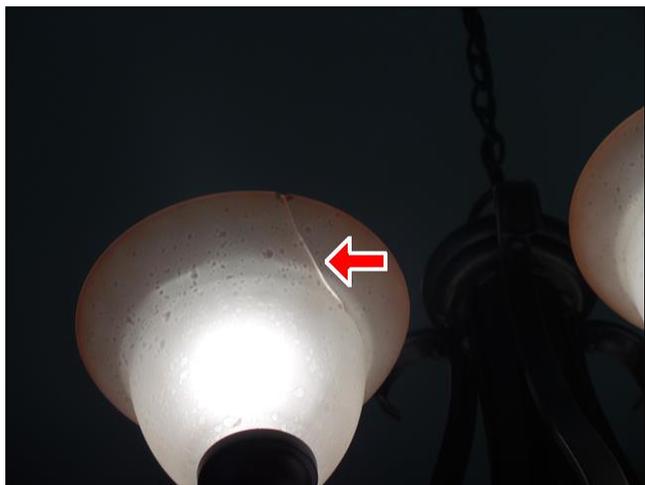
B. Item 1(Picture)

- 🏠 (1) Electrical outlet in the breakfast room (closest to the kitchen) is wired improperly with the hot and neutral wires reversed. All electrical devices today are polarized. That means the small slot in a receptacle should be hot and the larger slot is neutral. The half round opening is for the ground wire. If improperly wired, (i.e. reversed polarity), there is an opportunity for electrical shocks
- 🏠 (2) Damaged light cover was observed on the light fixture at the main entry way.

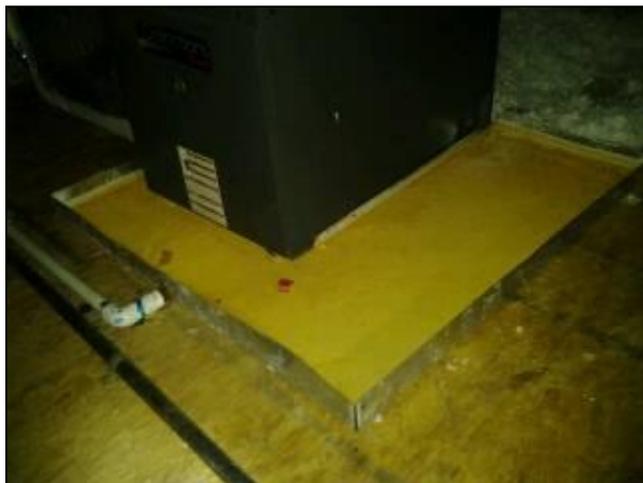
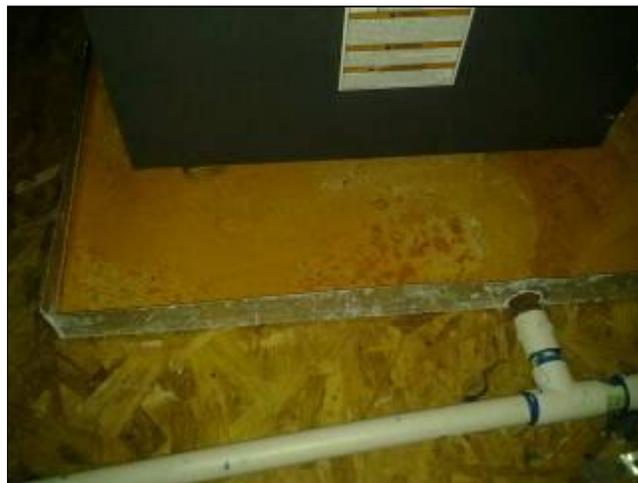
(2) Rust was noted in the safety pan under both evaporator coils in the attic. This should be cleaned professionally by a qualified and licensed HVAC contractor and replaced if the rust has damaged the corrosion resistant coating of the safety pan. After pan has been cleaned and/or replaced, the primary and secondary drain lines should be flow checked and cleaned if necessary plus checked for proper termination..

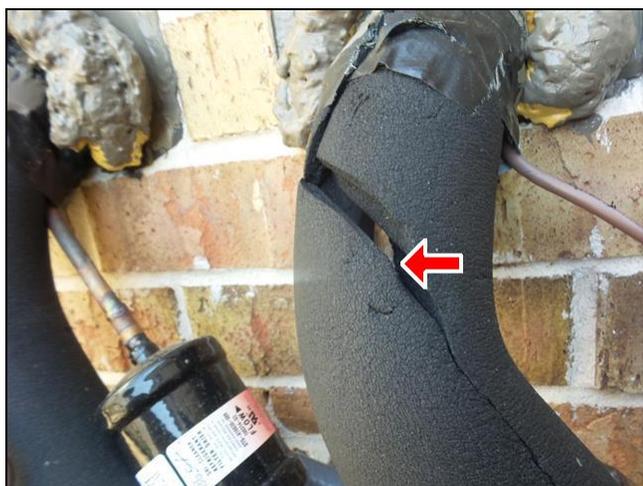
B. Item 3(Picture)

(4) One of The AC suction lines is not properly insulated at condenser unit. The larger diameter pipe is the suction line that carries refrigerant as a gas between the two units, this line gets very cold when operating due to the refrigerant being expanded into a gas. This line should be insulated for the entire length to help prevent the refrigerant from heating up due to the exterior temperature. If this line is exposed to the sun or heat, the cooling system will lose efficiency.

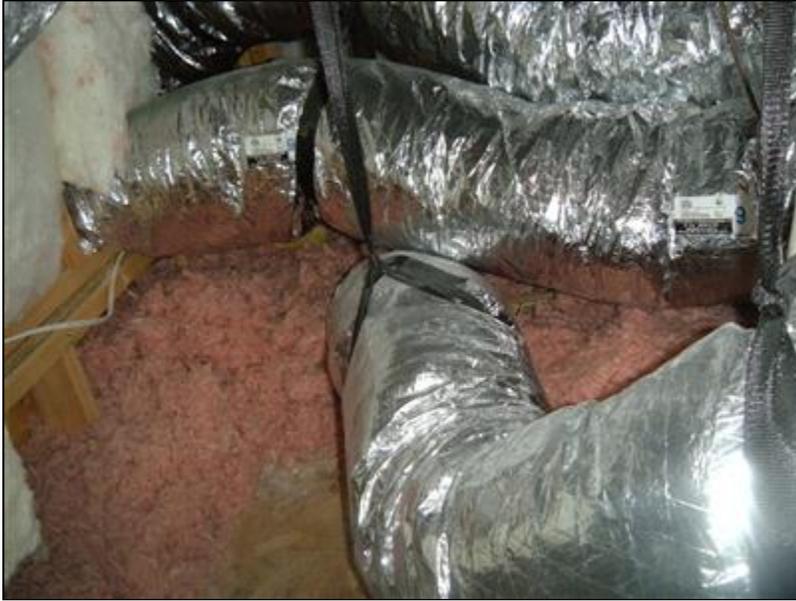
C. Item 1(Picture)

Observed several / multiple areas in attic where flex duct touch and are missing required 1" clearance from other ducts to prevent condensation between ducts that touch. Recommend general maintenance to flex ducts in attic, Re-support where needed, seal/tape minor air leaks, repair torn/damaged vapor seal, etc..

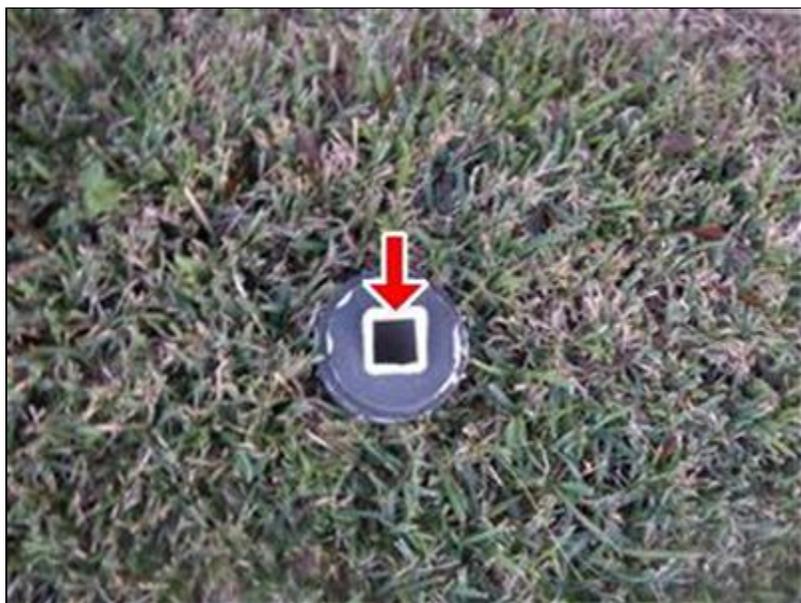
B. Item 1(Picture)

(1) The sanitary clean-out, in the rear of the house, has a damaged lid.

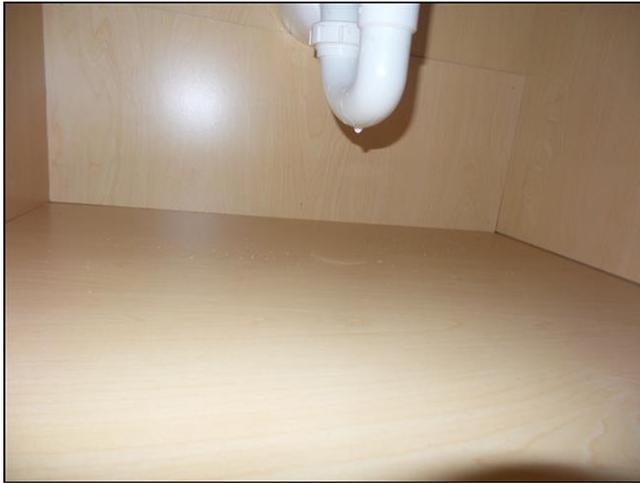
B. Item 2(Picture)

(2) The plumbing waste line leaks at the upstairs Hall Bath sink. Repairs are needed. A qualified person should repair as necessary.

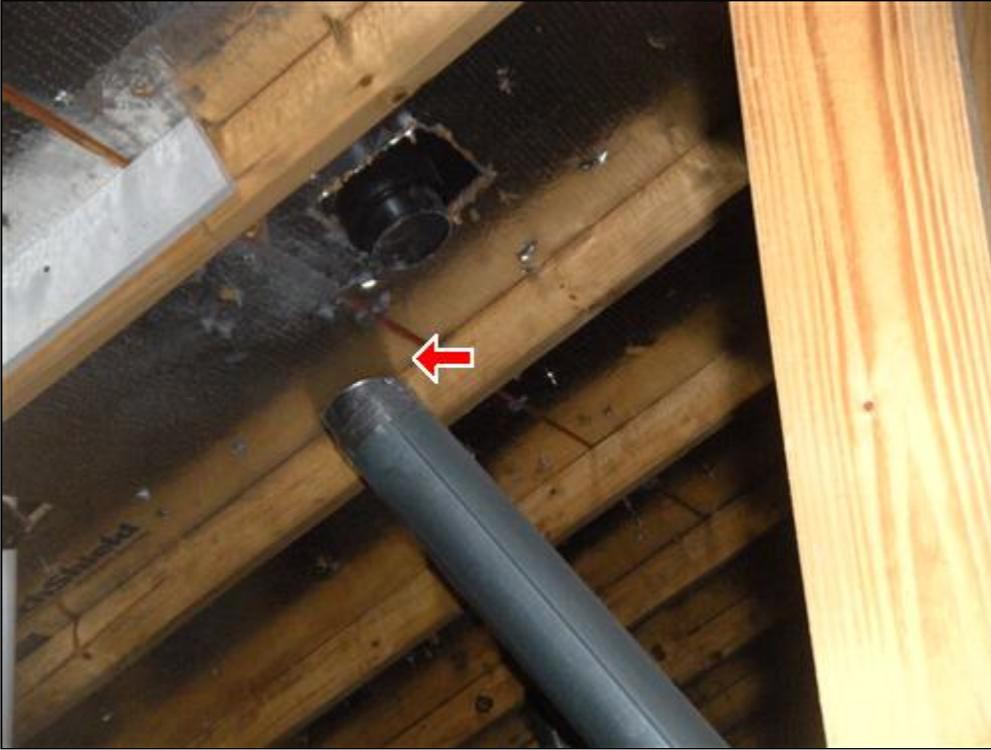
J. Item 1(Picture)

The clothes dryer vents into the attic. Dryers venting into the attic may deposit moisture, which can encourage the growth of mold, wood decay, or other material problems. This is also a potential hazard and should be repaired by a qualified contractor

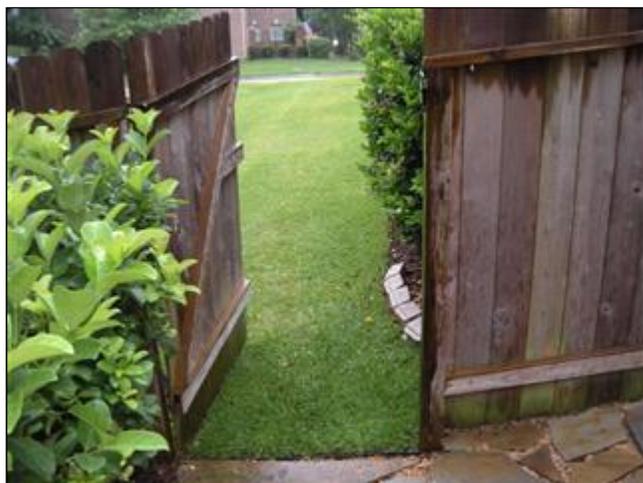
J.2. Item 1(Picture)

The pool fence (barrier) should be quipped with a self latching, self closing gate. The gate must open outward (away from pool).
